## Our Lady of the Assumption School (Hoon Hay)

Block 1 closed

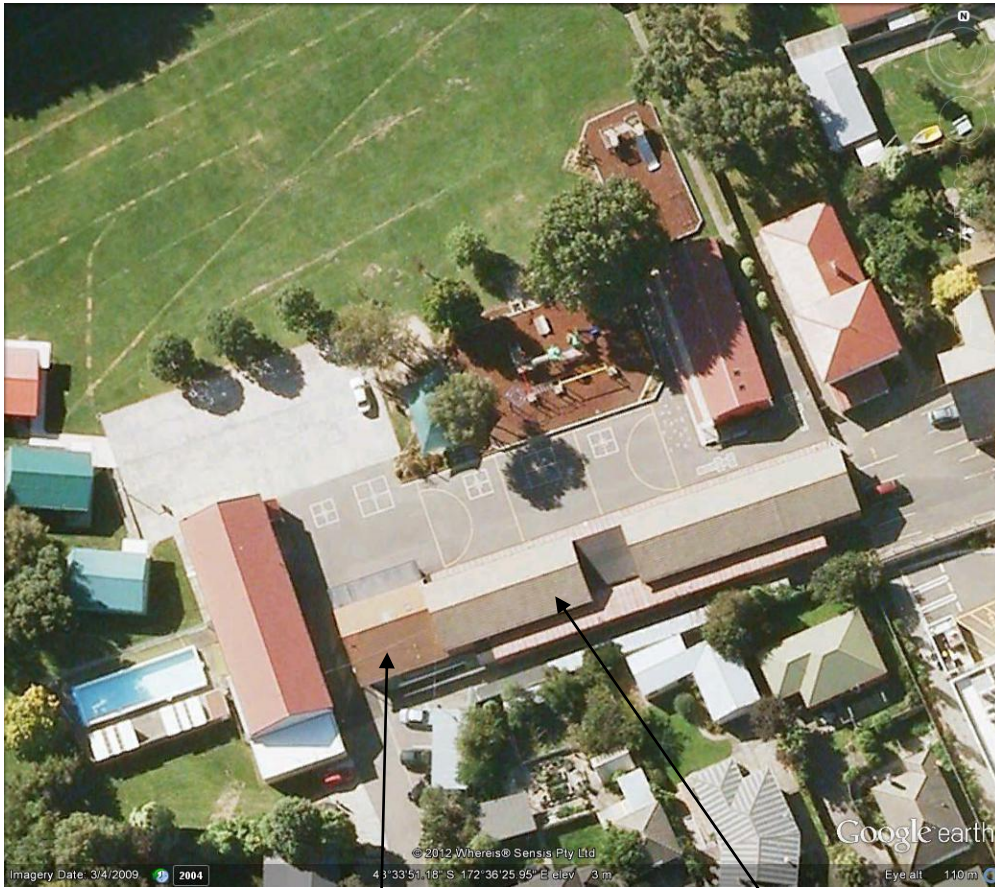
Admin area not affected

A preliminary engineering assessment of Our Lady of the Assumption School has revealed that the classroom section of Block 1 is earthquake prone and requires remedial work in order to meet appropriate building standards and be able to be re-occupied.

1. Five marquees (with associated flooring) will be installed at the school on Monday (20/02/12) morning.
2. A security company will be on site after school hours.
3. Hann Construction will be on site on Monday morning to commence the appropriate temporary bracing work that the structural engineers from Opus International have detailed and specified.
4. The strengthening scheme entails installing plywood bracing walls internally over existing walls to improve the capacity of the building, and remove the lines of weakness through the clear storey windows.
5. This bracing work will improve the seismic capacity of the building to as near as practicable to 67% of the new building standard.

6. When this bracing work has been completed the classrooms in Block 1 will no longer be considered earthquake prone and will be able to be re-occupied for teaching and learning.
7. It is anticipated that this bracing work will be completed within 7 – 10 working days.
8. Following the completion of this temporary bracing work the Diocese will commence the process of providing for a permanent and more cosmetically pleasing strengthening solution.
