St Mary's School Christchurch North

A preliminary engineering assessment of St Mary's School has revealed that the classroom section of Block 1 is earthquake prone and requires remedial work in order to meet appropriate building standards and be able to be re-occupied.

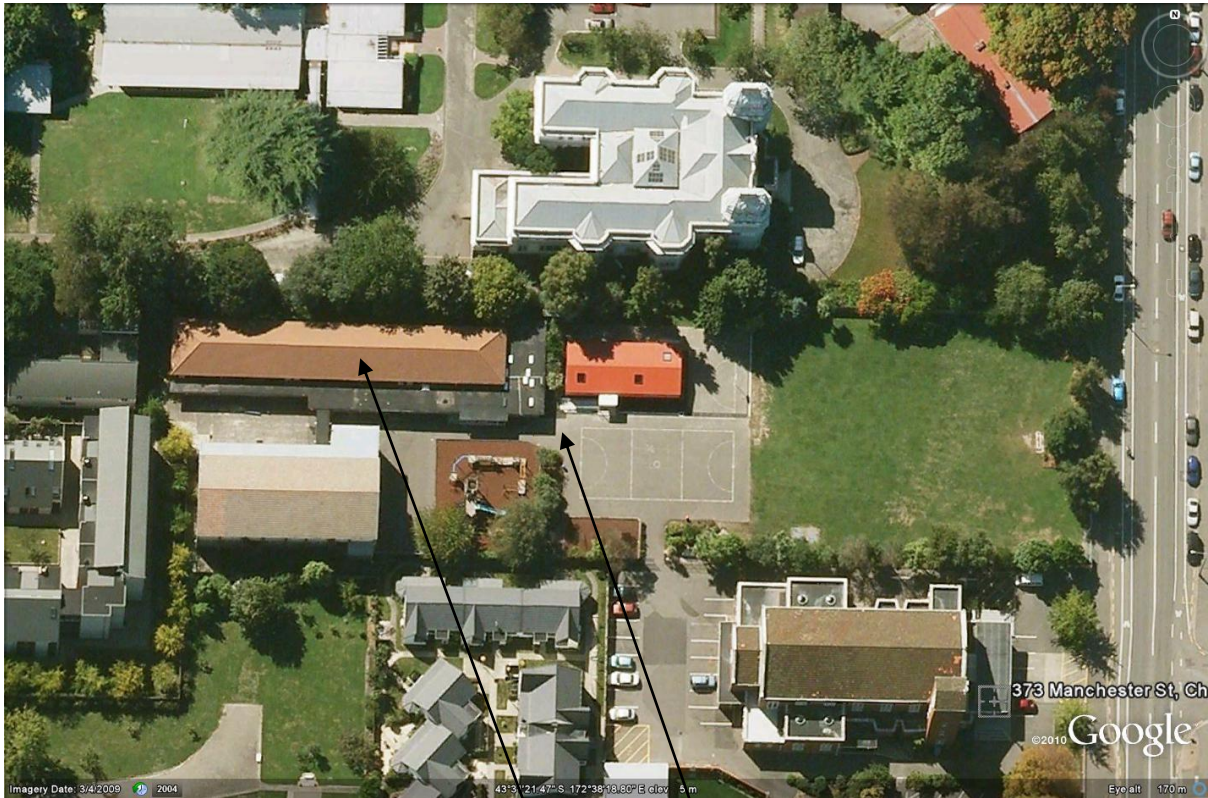
Block 1 Admin area not affected

4. Hann Construction will be on site on Monday morning to commence the appropriate temporary bracing work that the structural engineers from Opus International have detailed and specified.

5. The strengthening scheme entails installing plywood bracing walls internally over existing walls to improve the capacity of the building, and remove the lines of weakness through the clear storey windows.

6. This bracing work will improve the seismic capacity of the building to as near as practicable to 67% of the new building standard.
7. When this bracing work has been completed the classrooms in Block 1 will no longer be considered earthquake prone and will be able to be re-occupied for teaching and learning.
