### St Anne's Church Ferry Rd

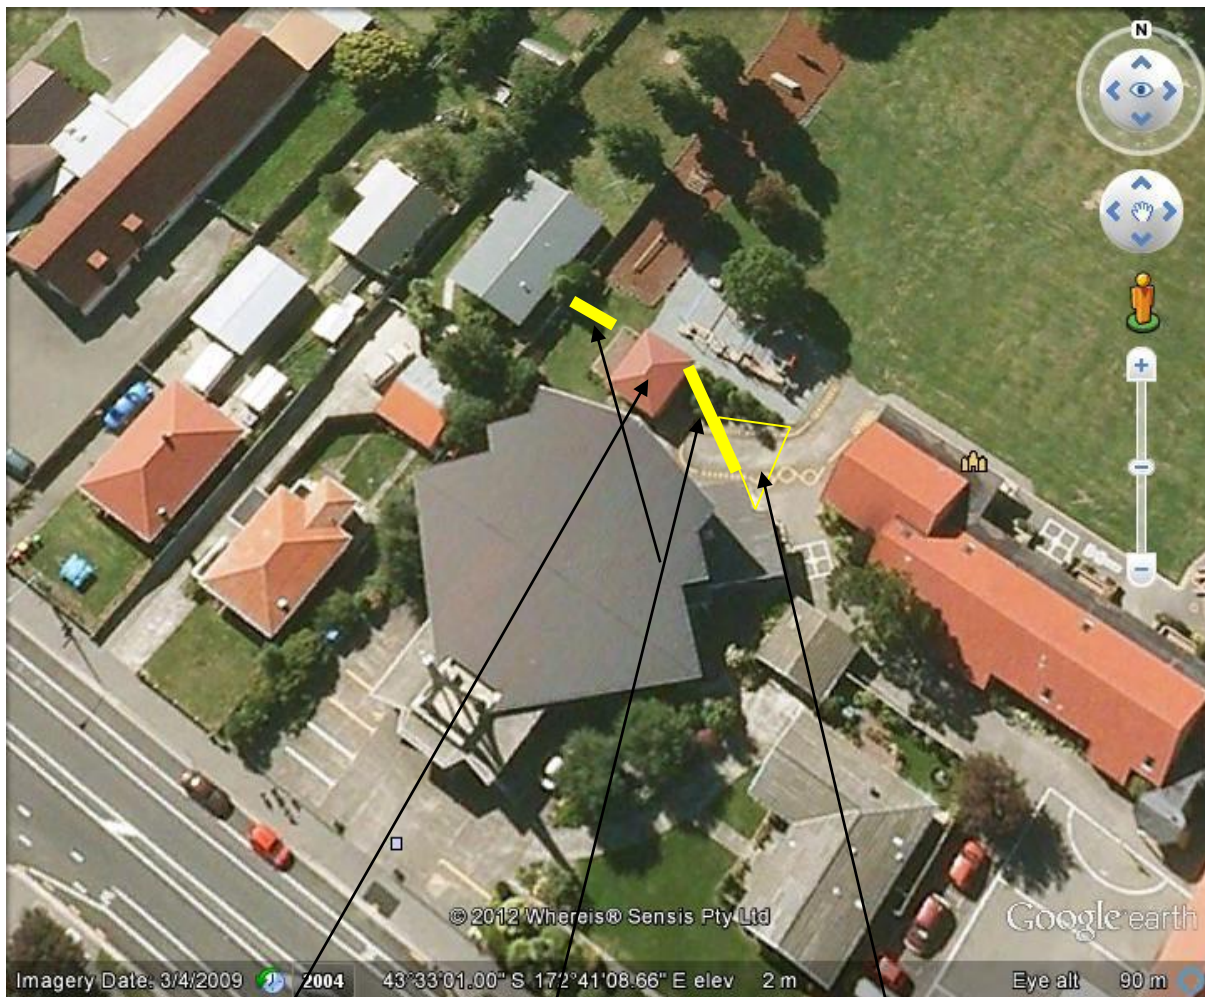
This building off limits

Temp Security fencing

This area no congregating

Our inspections and assessments of the church have identified a potential weakness that we are investigating further at this time. It is considered that the NE wall of the church may fail in a significant quake. (Some fresh damage to the wall has been noted since 23 December).

For this reason we have cordoned off the church as per the aerial view above which will make Block 4 closest to the church wall off limits - as noted.

We consider that there is minimal risk to people outside this cordon but there should be no congregating close to the NE wall within the yellow triangle shown above.

We are looking into the possibility of a temporary propping solution to allow the church to re-open, which would involve an internal brace and some

containers outside – possibly affecting the veggie garden. We will know early next week whether this is a viable option after we've inspected the building further.

If we are able to undertake temporary propping it will take 10-14 days to complete this before we can re-open the church. In the **meantime access to the church should be limited to two people at a time for short periods only.**
